Sustainability in Vehicle Repair and Replacement

A Project Study conducted by Zhibin Cheng, Yuxi Chen and Sandra König

Building upon the existing AZT and Allianz SE study: "Repair or Replace - Investigating the relative GHG emissions of repairing or replacing damaged vehicle parts" focused on the VW iD.3 (BEV-Battery Electric Vehicle), this study broadens the scope of application to include an Internal Combustion Vehicle (ICV).

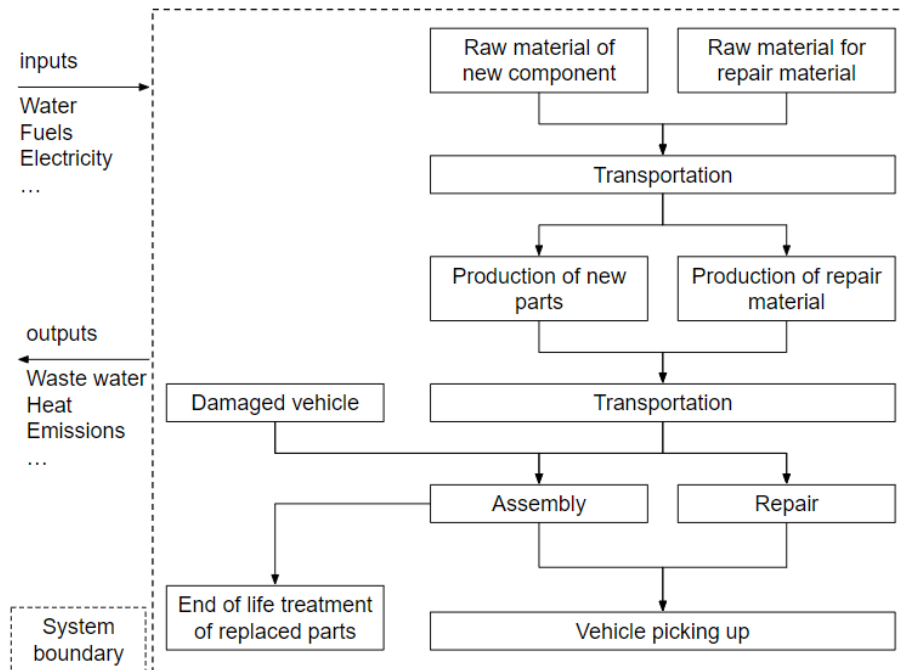
Figure 1: General Flowchart; source: own illustration

The Lifecycle Assessment (LCA) methodology is a fundamental component of this study. By analysing the environmental footprint of repair and replacement decisions, we aim to provide a comprehensive understanding of sustainability within the automotive industry. Our calculations are based on the openLCA software. Our flowchart shows the framework of our study and the areas examined and included.

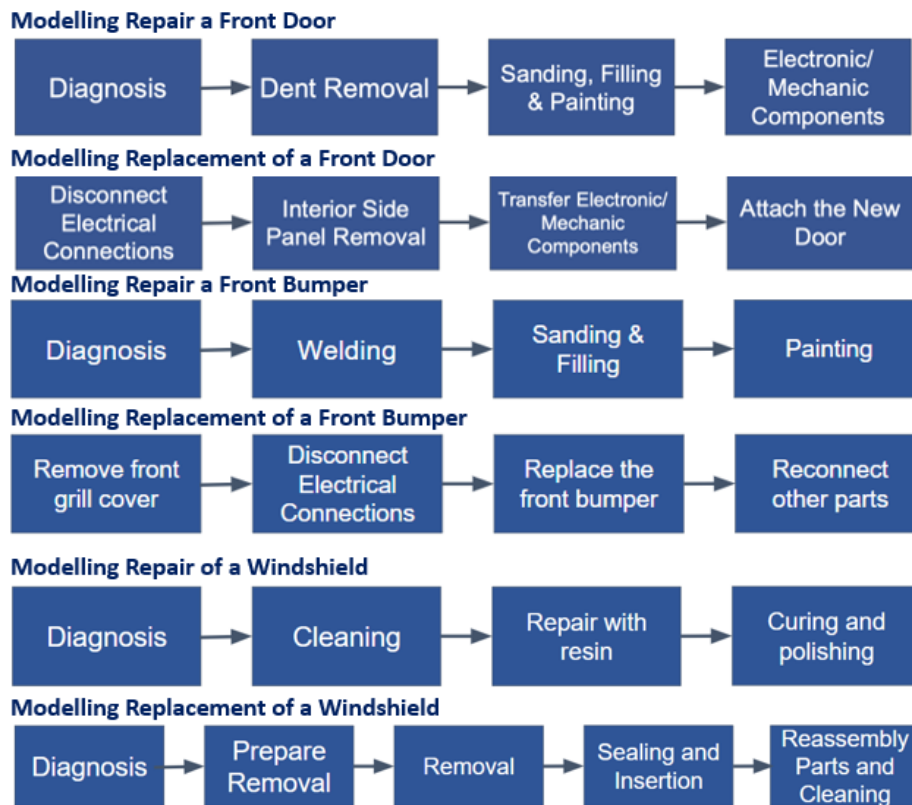
Figure 2: Modelling repair and replacement of a front door, a front bumper and a windshield; source: own illustration

The figure illustrates our damage scenario for the front door, windshield and front bumper:

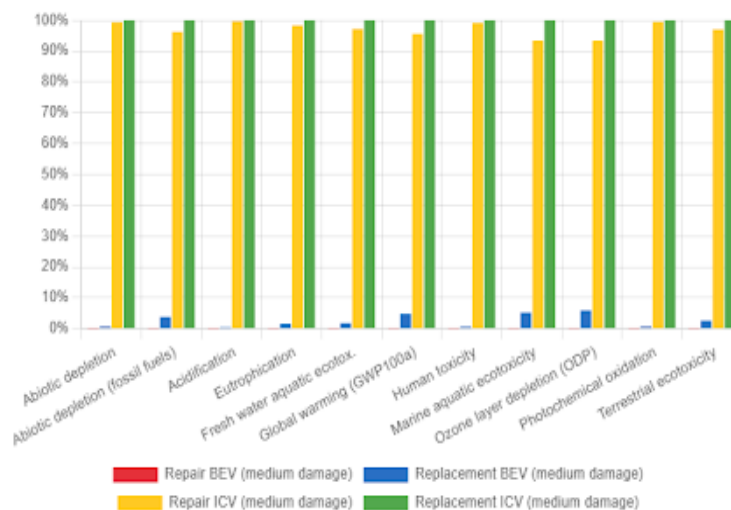
Figure 3: Medium damage LCIA result in all categories; source: own illustration and openLCA

- BEV: Medium dents on the battery protection plate - Repair or replace is possible.
- ICV: Medium dents on the catalytic converter - Replacement is needed.
- ICV's environmental footprint increases due to precious metals in the catalytic converter, while the BEV's footprint can be further decreased by repairing the plate.

The following Figures 3, 4 and 5 are representing a short overview of our main results:

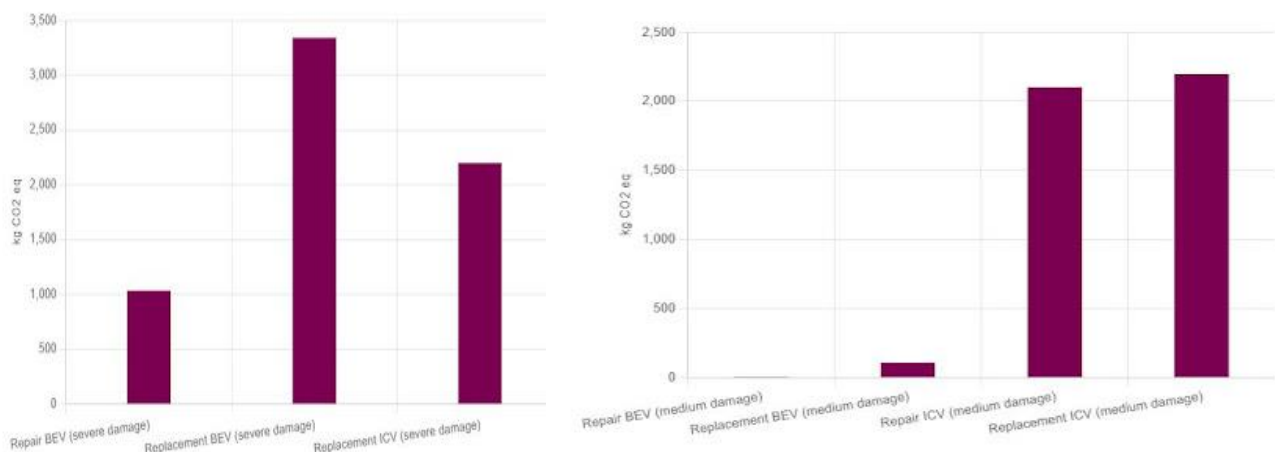
Figure 4: Severe and medium damage LCIA results on GWP100; source: own illustration and openLCA

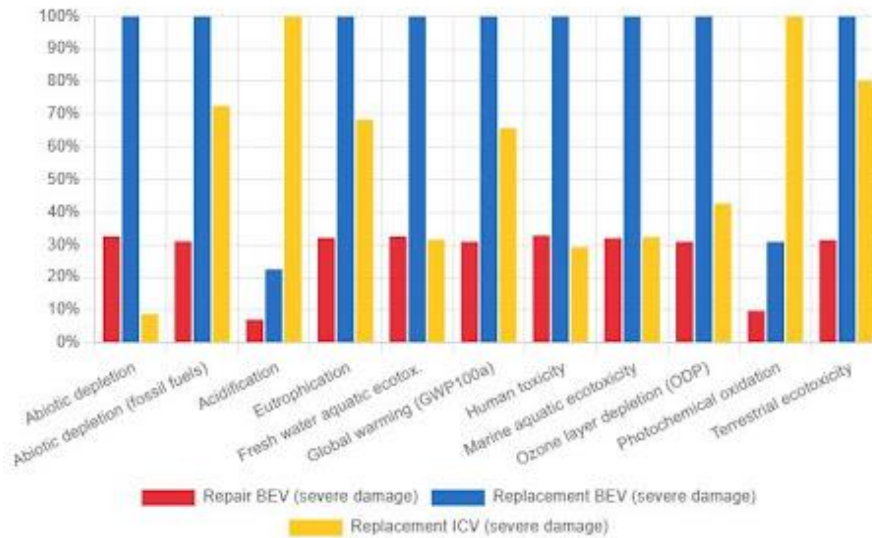
Figure 5: Severe damage LCIA Result in all categories; source: own illustration and openLCA

- BEV: Partial intrusion (1/3) into the vehicle battery - Repair or replace is possible.
- ICV: Severe damage to the exhaust system - Replacement is needed. Even with partial battery replacement, the BEV footprint is greatly increased.
